# Basin Construction

Leak detection layer, El Golfo - La Frontera, El Hierro, CANARY ISLANDS

## Case Study

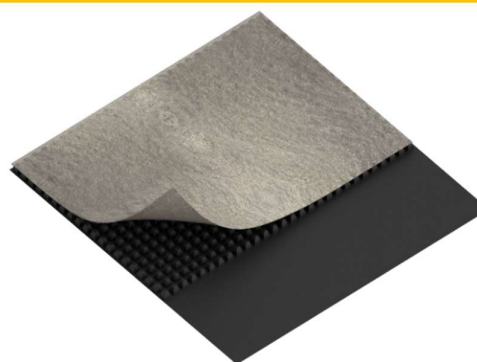
**Pozidrain 6SK250/NW16[L80]**

- Certified long-term performance
- Drainage layer includes flat seldedge overlap to provide an impermeable, secondary protection and leak detection layer directly beneath the waterproofing
- Lightweight to transport and fast installation, requiring no additional excavation

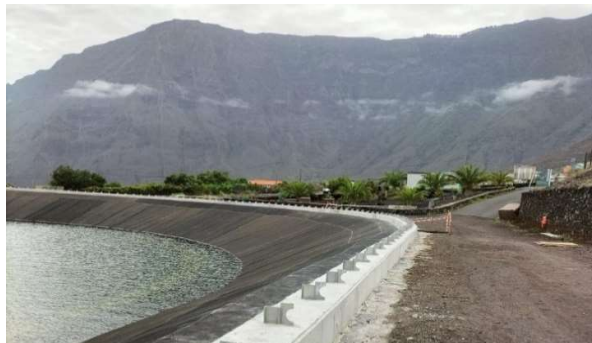
Completed basin lining prior to fabric cover installation

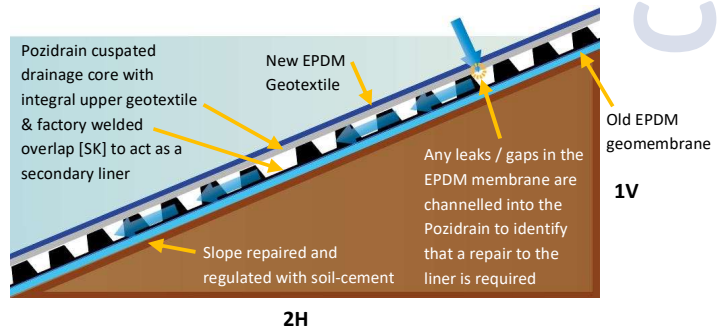
**Pozidrain installed to line the base of the reservoir with cusps and upper geotextile facing upwards to channel and detect any leakages in the primary EPDM waterproofing. The underside of the core is impermeable and joined with a selvedge overlap.**

ABG's Pozidrain geocomposite was specified for the leak detection and drainage layer and to alleviate the risk from pore water pressure causing wider spread damage in the event of a tear. The 6mm deep cusped drainage

core provides a controlled in-plane flow rate that is equivalent to an approximately 150mm thick layer of stone, whilst the integral geotextile bonded to the upper surface of the core serves to filter and prevent any sediment from blocking the drain. Large roll sizes of 5.5m wide x 96m length provided rapid coverage to line the basin. Also integral to the success of the installation was the specification of the 5.5m wide Pozidrain with a factory welded selvedge core. Adjoining rolls were then overlapped and sealed using an extrusion welder to heat bond the geotextile and HDPE core layers together. Collector drains at the bottom of the basin enable any water channelling through the cusped core to be detected and the source of any leaks identified. Producers in the Valle del Golfo are now able to use the irrigation water from the renovated reservoir, with the installation of a new fabric roof to minimise evaporation, new lighting and the improvement of the inlet collector to follow.
