Basin Construction

Groundwater drainage and leak detection beneath snow pond,
Pozidrain, San Martino di Castrozza [TN], Italy

CASE STUDY

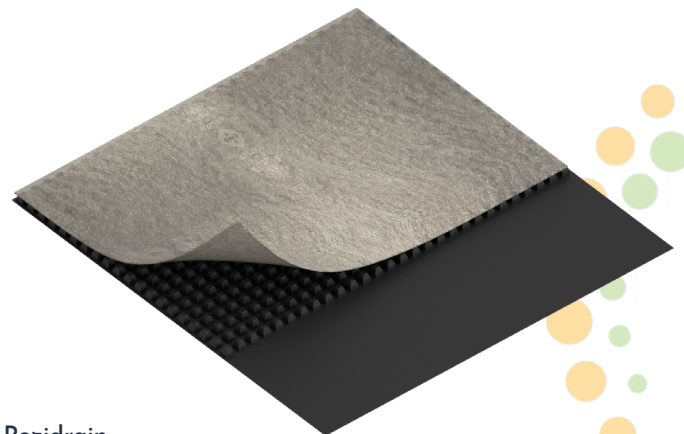
Pozidrain 4SK250/NW8 [L] was laid textile to soil as a groundwater drainage layer. It was chosen to provide a thin and effective water pressure relief membrane, having a flow capacity sufficient to cope with the groundwater conditions expected locally. This version of Pozidrain was

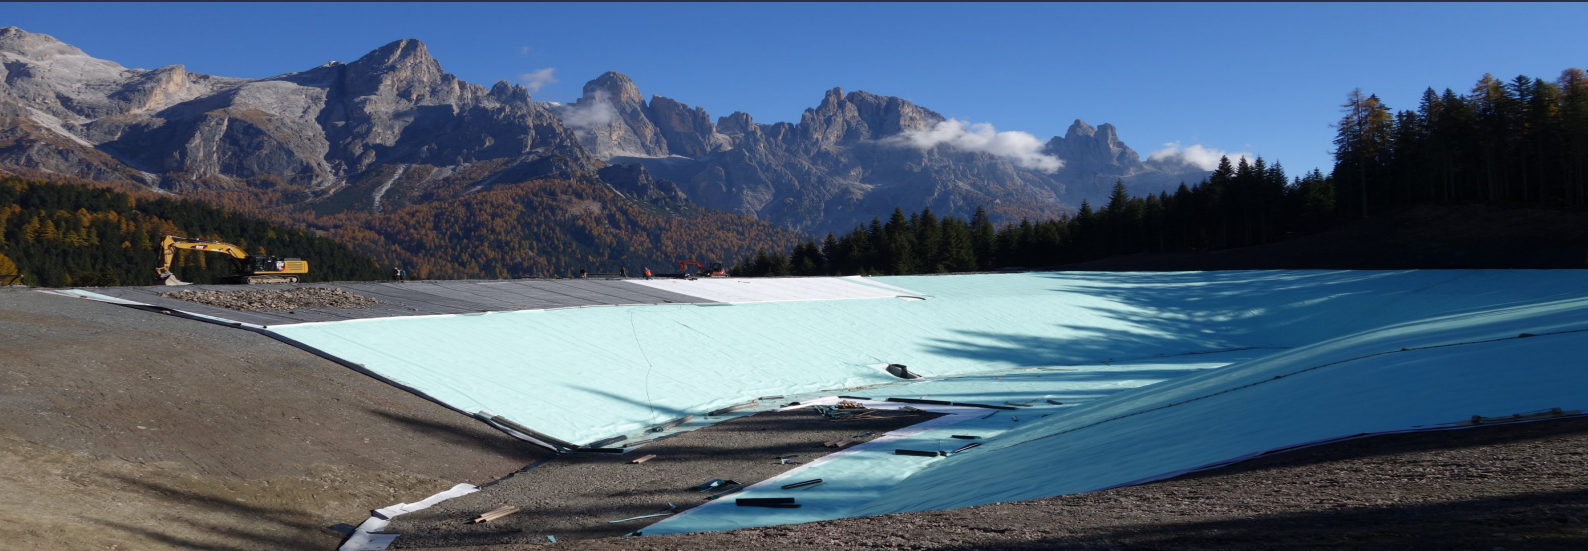
also selected for both its long term creep resistance of up to 250kPa and for resistance to installation loads. The addition of an "L" flat selvedge down one edge of the Pozidrain 4SK250/NW8 [L] rolls enabled a pressure seal between adjacent rolls which assist in preventing leakage from the pond if the liner is damaged. A second layer with textile facing upwards was placed directly underneath the liner, back to back with the first, to provide a leakage collection, drainage and monitoring layer. The double layer was only required on the slopes facing the mountainside for groundwater pressure relief (see function diagram on the right). On the valley side, a single layer for leakage collection was installed.

Dual layer of Pozidrain 4SK250/NW8 installed back-to-back to provide groundwater drainage & leak detection functions

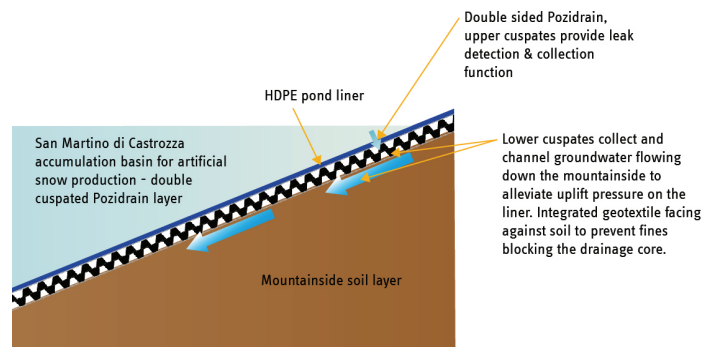
Dual layer of Pozidrain 4SK250/NW8 installed back-to-back to provide groundwater drainage & leak detection functions

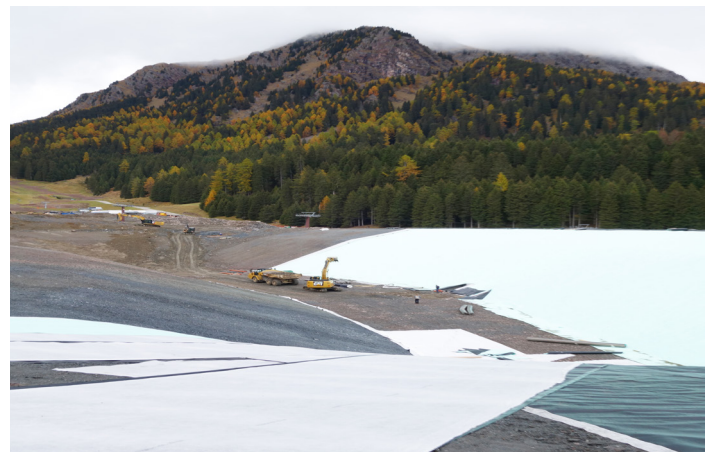
The completed accumulation basin at the foot of the Ces Valcigolera ski run, San Martino di Castrozza
