# Capillary Break

Salt Barrier, Dubai Water Canal, UAE

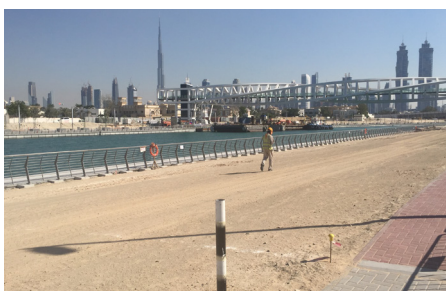
ABG Salt Barrier installed underneath landscaping running along the side of the canal

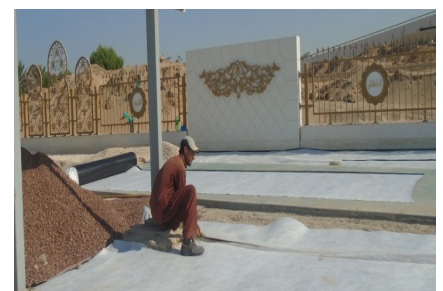
Installing the Salt Break ensuring the overlaps of filter geotextile prevent cover soil entering the capillary break void and causing tracking
