ABG Erosamat 3/20Z 500M

# Erosion Control

Reinforced Grassed Spillway, Erosamat TRM, Grassholme Reservoir, UK

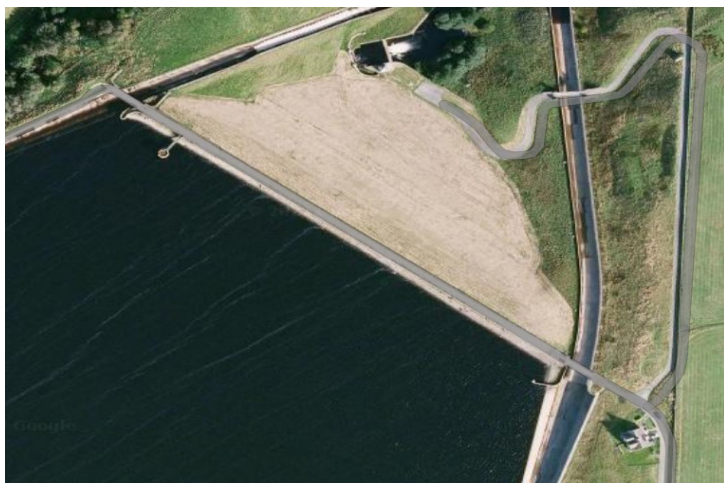
Aerial image of the spillway location

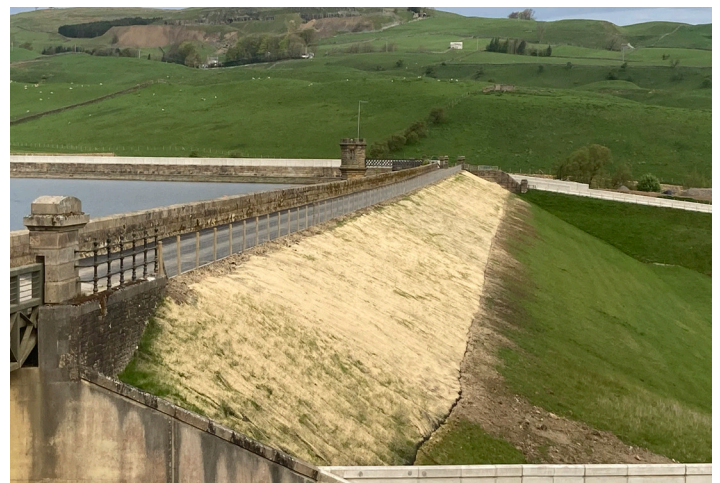
Vegetation beginning to re-establish

Once in place, the Erosamat was Hydroseeded. Now complete on site, vegetation has started to develop through the Erosamat, and will soon completely cover it, allowing the farmer to let his sheep graze on the embankment once more.
