Erosion Control

Reinforced Grassed Spillway, Erosamat TRM, Grassholme Reservoir, UK

Case Study

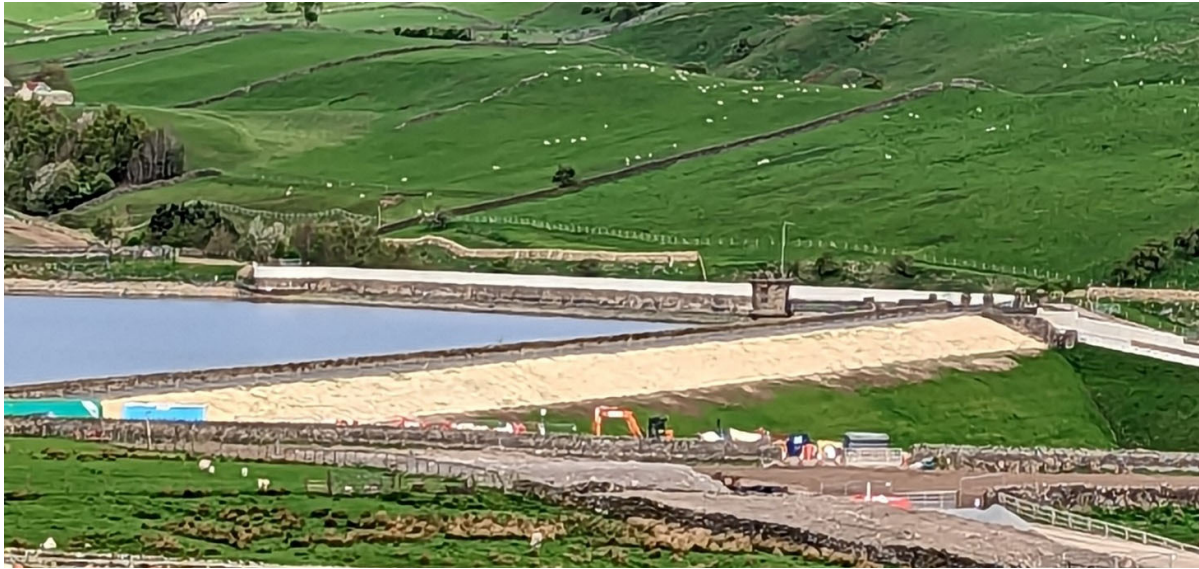
The face of the dam crest and the spillway required improvement to better cope in the event of overtopping. Water will flow down the spillway face at speeds over 4m/s and an unreinforced and well-established grass sward would only withstand these flow speeds for a short period.

To improve resilience and extend the period that the spillway can withstand an overtopping event, ABG's Erosamat 3/20Z 500M erosion control geosynthetic was chosen as a permanent Turf Reinforcement Mat (TRM) that meets the design requirements of CIRIA Report 116 and to protect against die-back of the grass.

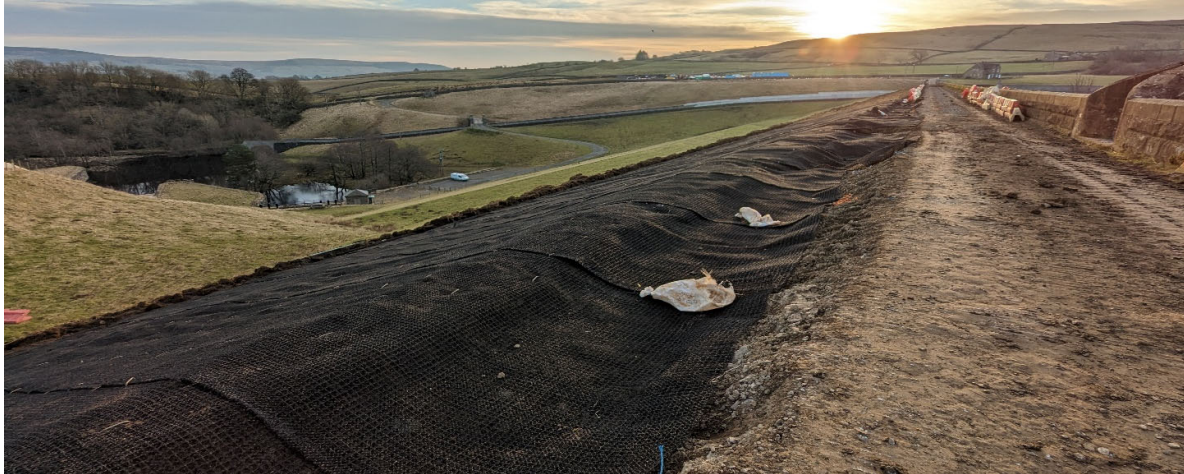
The face of the dam is roughly 45°, so access was not very easy (especially during the Winter months) and Health & Safety was of prime concern. Stripping the vegetation was challenging, and a remotely operated flail mower was used to reduce the risk of operatives slipping down the bank. Unlike traditional Erosamat installations, both the top and toe anchors were to be undertaken in a slightly different manner. The Erosamat was anchored at the top under the newly installed kerb for the access road along the crest of the dam, whilst the toe trench was a 700mm slit trench cut using a GeoRipper. This reduced the manpower needed on the face of the dam and, again, reduced risk.

Once in place, the Erosamat was Hydroseeded. Now complete on site, vegetation has started to develop through the Erosamat, and will soon completely cover it, allowing the farmer to let his sheep graze on the embankment once more.

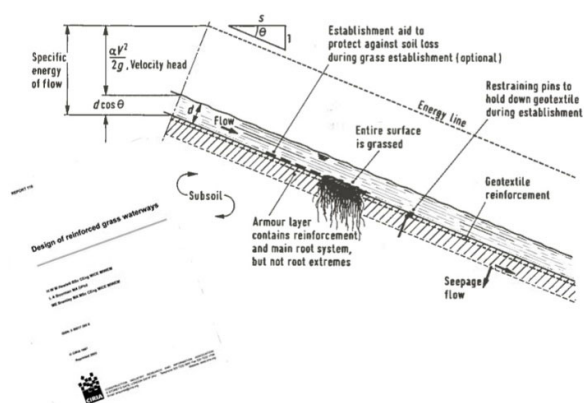
CIRIA Report 116 Design of grass reinforcement

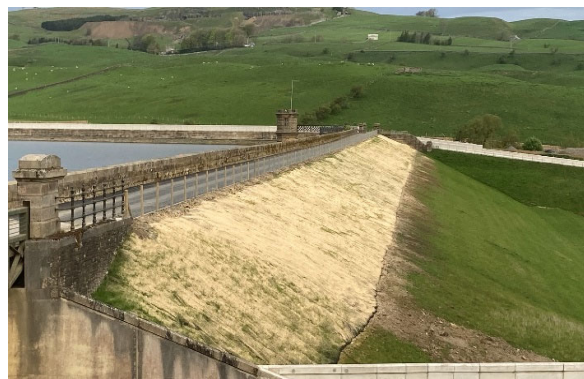
Vegetation beginning to re-establish
