Reinforced Grassed Spillway, Erosamat, Aller Moor, Somerset, UK

Case Study

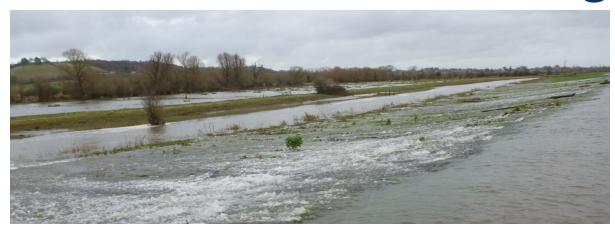
ABG Erosamat 3/20Z 500M

as an open mat under CIRIA Report 116, 'Design of Reinforced Grass Spillways', **Erosamat** provides a permanent and effective surface erosion control and vegetative root reinforcement layer.
