Landfill Drainage

Landfill Capping, Pozidrain, Sundon Landfill, Luton, UK

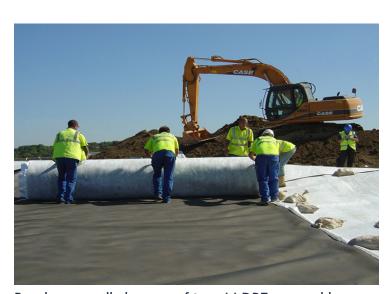
Pozidrain installed on top of 1mm LLDPE textured liner

Robert Long Consultancy and Bedfordshire County Council worked with ABG to develop a geosynthetic capping solution that would provide adequate drainage and frictional performance to ensure slope stability. Pozidrain 7S25OD/NW8 geocomposite drainage layer was specified and installed on top of the 1mm LLDPE textured membrane.

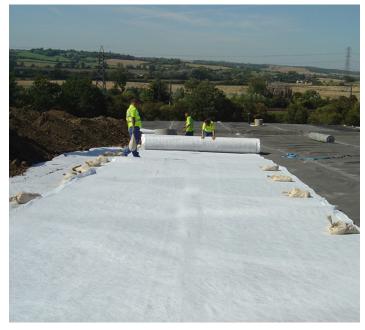
Large rolls enabled rapid installation

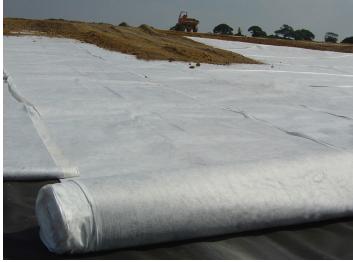
Adequate interface friction ensured slope stability

A large proportion of the landfill cap was on 1 in 4 slopes where it was necessary to ensure slope stability during construction.
