# Landfill Drainage

Leachate Detection Layer, Pozidrain SK[L], East London, South Africa

CASE STUDY

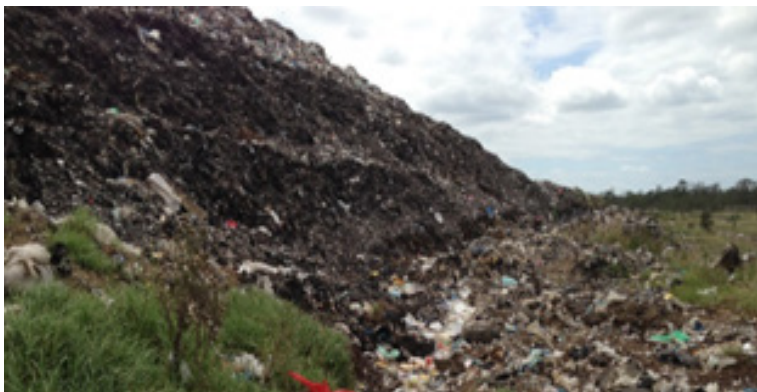
Old cells with unsafe, uncompact steep side slopes

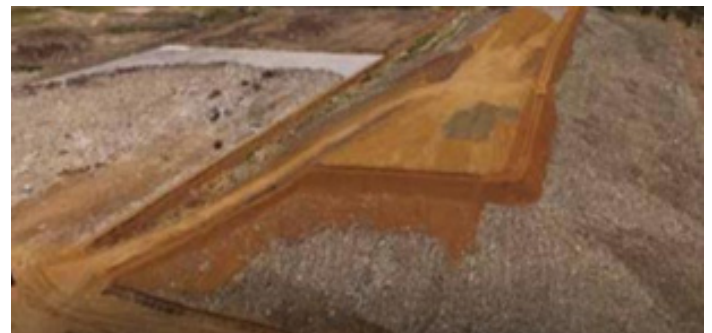
Reshaped cells 1 & 2 and start of temporary covering layer
