# Retaining Wall

Webwall, Ramsden Reservoir, West Yorkshire UK

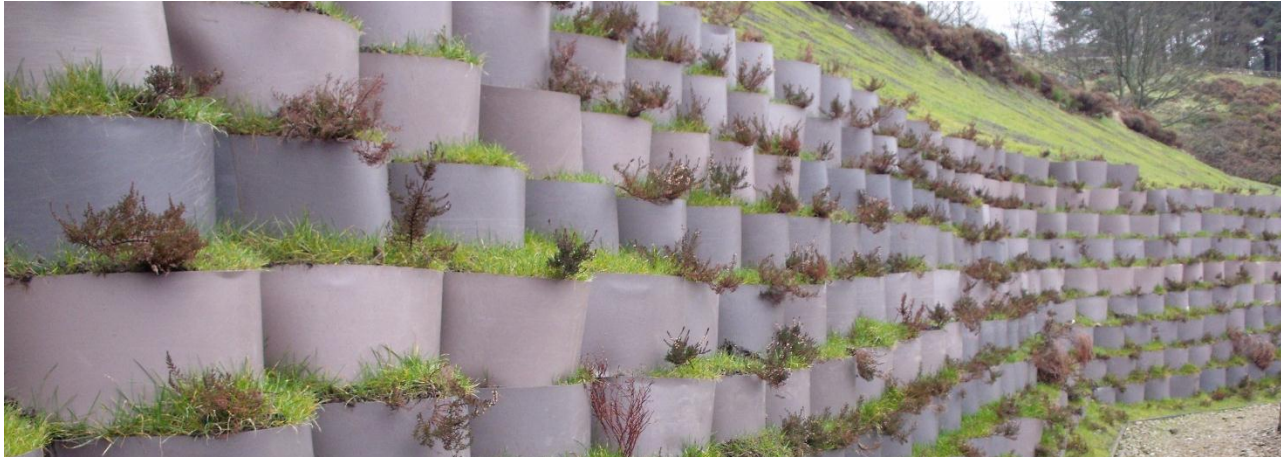
**ABG's Webwall** was chosen as it successfully met the brief and offered further advantages as it allowed the use of existing fill from site. This significantly reduced the number of vehicle movements around the site, costly removal of the soil to landfill and the amount of imported fill required.

For this project **Webwall** was produced in a bespoke colour to the client's requirements. The colour was selected to blend into the background of the local soil and heathers minimising the visual impact of the wall whilst the vegetation was establishing.

**Trigrid EX** geogrid was incorporated into the design as it gives high strength at low strain and **ABG Fildrain** drainage geocomposite was used to ensure sufficient drainage behind the structure. After six months the **Webwall** facing was almost completely obscured by the established vegetation.

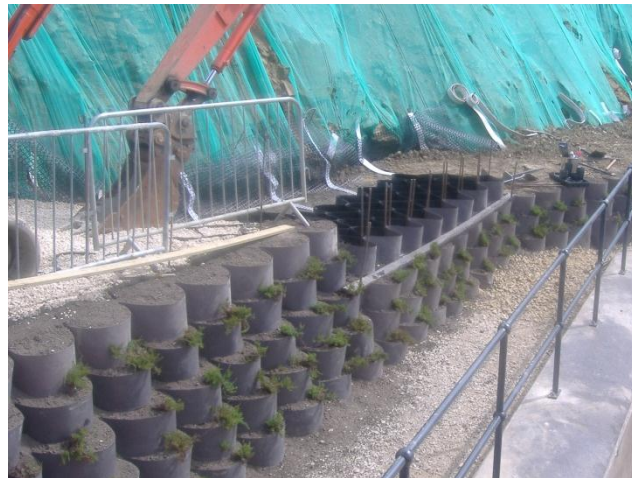
**Webwall being constructed and filled**

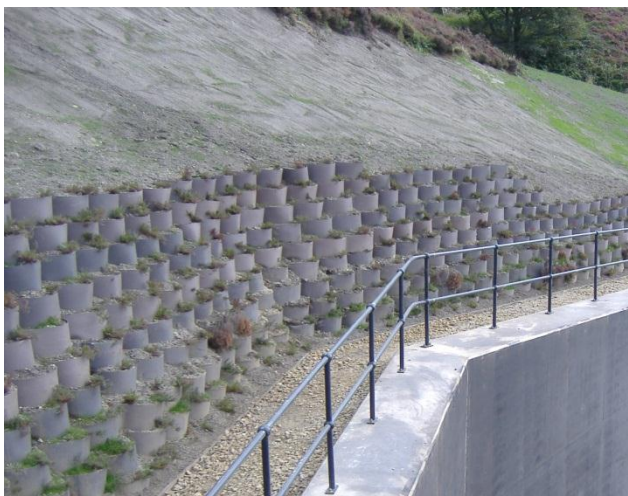
**Completed webwall**

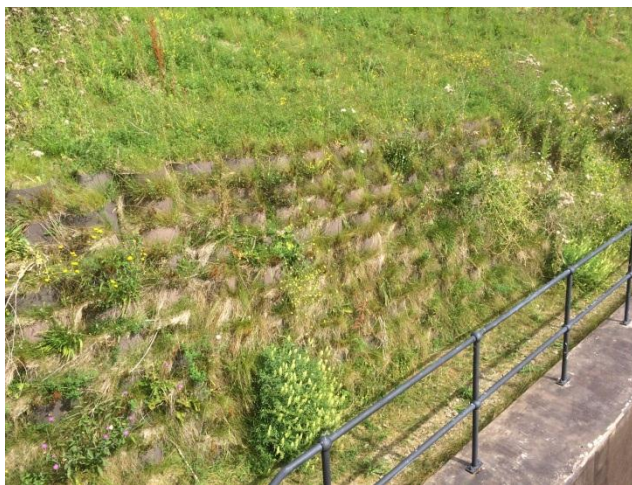
**Established vegetation**
