## Capillary Break & Root Barrier

Salt & Tree Root Barriers, Commercial Boulevard, Qatar

ABG Salt Break

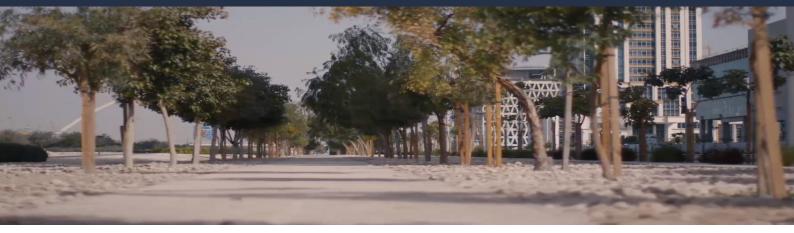
Rootline with ribbed lining installed to the outside of the tree pit to deflect and contain roots

ABG's ribbed Rootline root barrier layer was wrapped directly around the outside of the tree pit support system (inside of the salt barrier layer), consisting of an impermeable, pocketed high density polyethylene (HDPE) sheet to provide a robust layer against root spread and penetration.
