ABG Erosamat 3/20Z 500M

Erosion Control

Flood Embankment, Erosamat, Old Ferry Wharf, Barrow Haven, UK

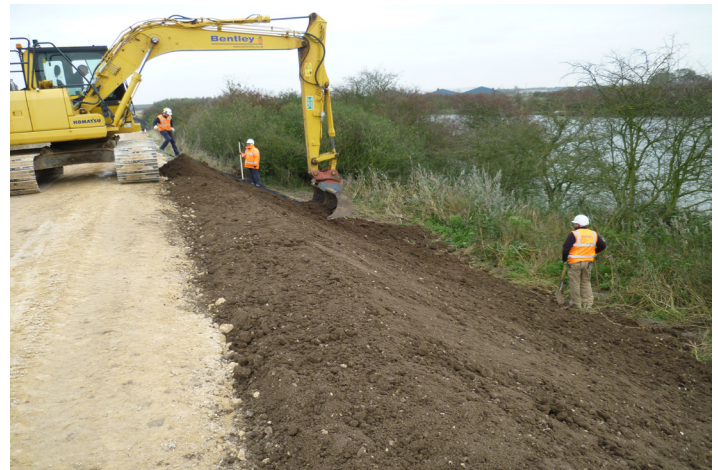
Topsoil is placed on the slope, overlain with Erosamat, pinned into place and secured by an anchor trench at the top and bottom of the slope. It is then seeded and buried with a thin layer of additional topsoil.

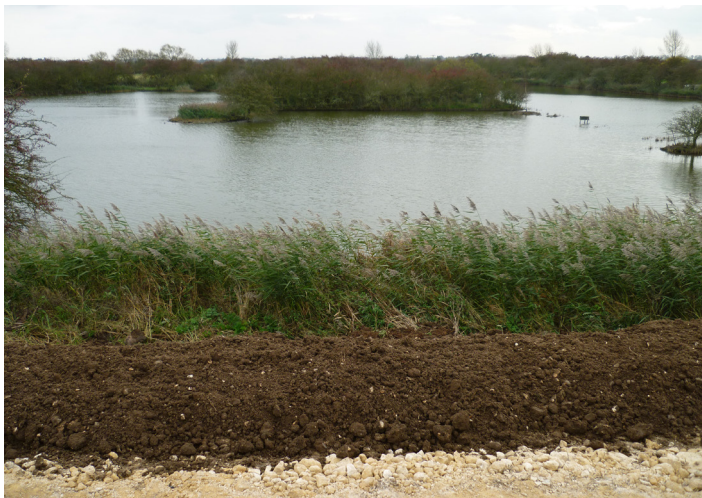
The embankment protects the freshwater lagoons on the other side of the sea defences.

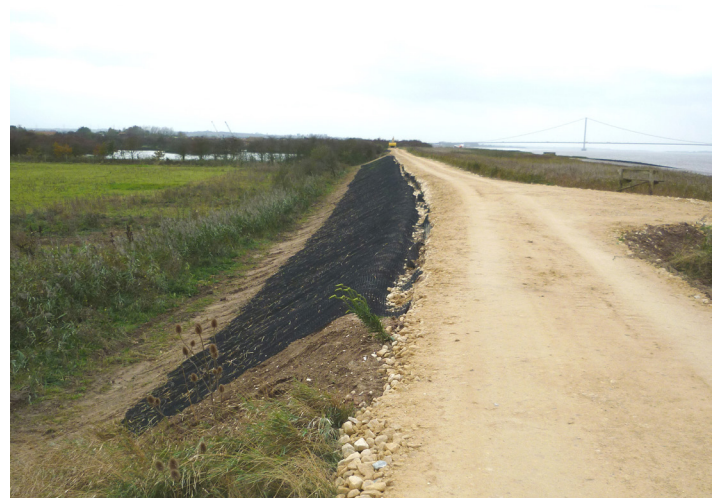
The Erosamat and anchor trench is ready for backfilled with topsoil. ABG Abgrid biaxial geogrid was used to reinforce the crest which acted as an access road.
