Erosion Control

Reinforced Grassed Spillway, Erosamat, Aller Moor, Somerset, UK

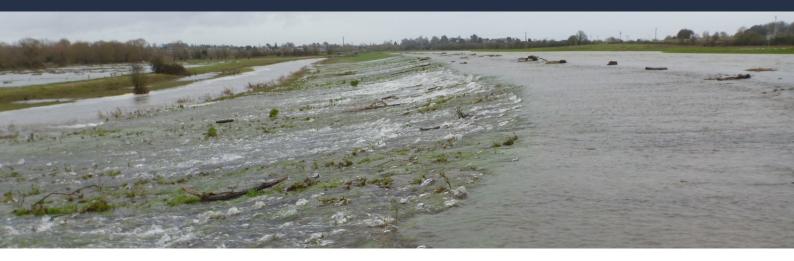
- Flow depth and velocities were recorded on Aller Moor spillway during flooding on 23 January 2014.
- Erosamat protection system. Installation was installed in September 2013.
- There was only minor grass coverage in January 2014.
- The un-vegetated Erosamat system provided the required level of spillway protection for the velocities exceeding 4m/s

Data collected by Black & Veatch during the overtopping floods in January 2014

Denth on	Discharge intensity (m³/s)	Velocities (m/s)						
		On Crest	7m from	9m from	10m from	20m from	30m from	
	(m³/s)		crest	crest	crest	crest	crest	
0.10	0.10	0.99	1.40	1.79	1.88	1.91	1.91	
0.20	0.28	1.40	2.09	2.38	2.56	2.88	2.89	
0.30	0.51	1.72	2.54	2.83	3.01	3.62	3.68	
0.40	0.79	1.98	2.88	3.17	3.36	4.17	4.33
