Erosion Control

Flood Embankment, Erosamat, Old Ferry Wharf, Barrow Haven, UK

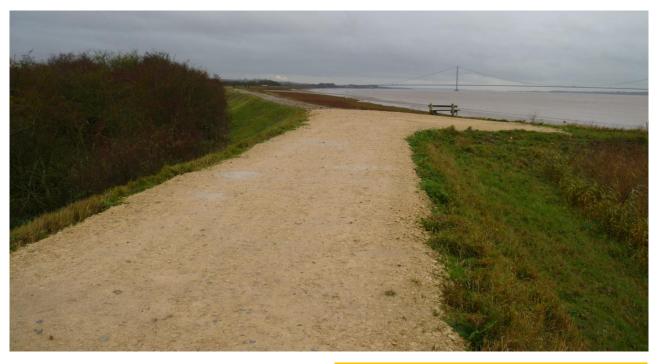
ABG Erosamat 3/20Z 500M

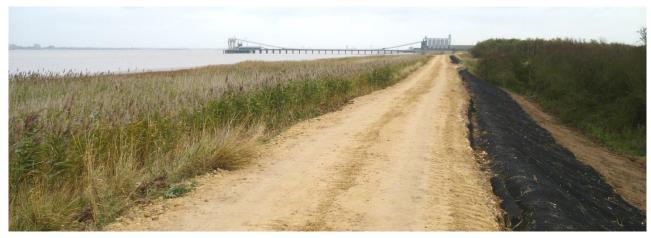
Topsoil is placed on the slope, overlain with Erosamat, pinned into place and secured by an anchor trench at the top and bottom of the slope. it is then seeded and buried with a thin layer of additional topsoil.

The Erosamat and anchor trench is ready for backfilled with topsoil. ABG Abgrid biaxial geogrid was used to reinforce the crest which acted as an access road.

ABG Erosamat 3/20Z 500M was chosen by Halcrow as an open three-dimensional turf reinforcement mat anchored firmly at the top and bottom of the back face. Erosamat acts to mitigate the damaging effects of surface erosion in flood events. The grass roots entwines with the Erosamat to provide root anchorage and has been proven in high flow environments to extend the design flow event to many times more than unreinforced grass.
